# CRAFTSMAN IN DISGUISE

A massive restoration returns a weary “Colonial Revival” to its origins

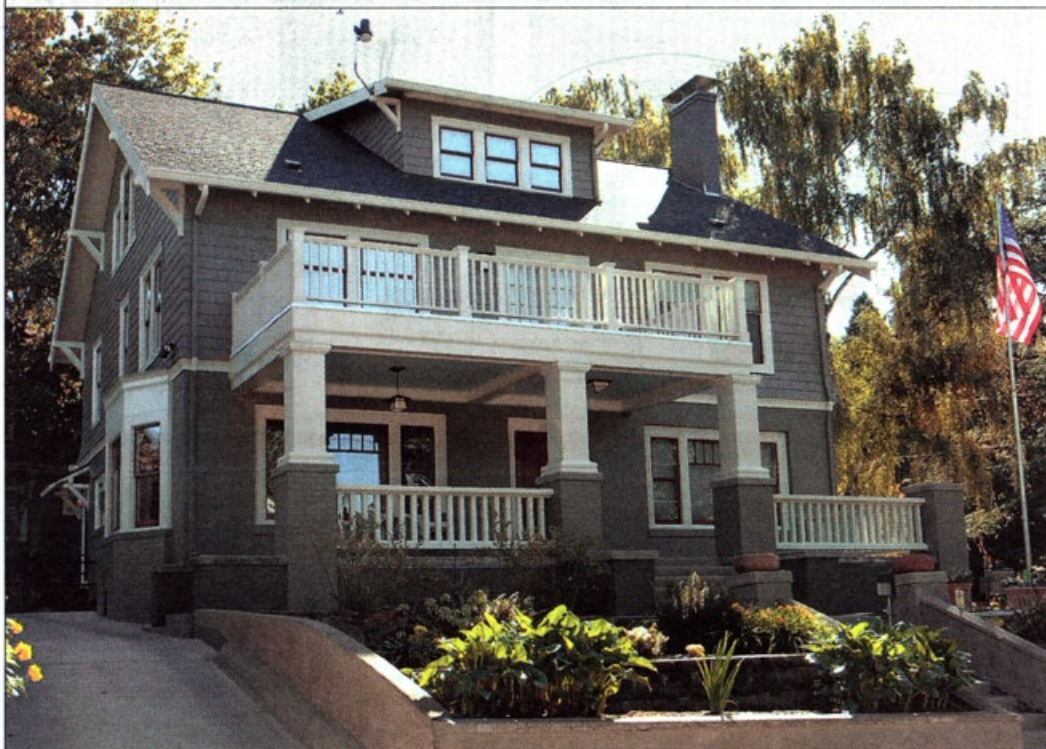
## | AFTER |

A 1912 Craftsman masquerading as a Colonial Revival, below, finally sheds its 1930s-era facade. Owners Terry and Mark Lewis were inspired by a photo of their Colonial Heights home in a 1912 issue of the Oregon Journal.

Freitag's crew began by bringing back the lovely extended eaves and ornamental rafter tails. They also restored the barge rafters and roof brackets. They repaired existing trim and moldings throughout and replaced the shingle siding on the home's second and third stories. They also replaced at least a dozen windows, including the two oversized "picture windows" in front.

Best of all, they rebuilt the front porch with massive brick piers and columns, and put back the second-story balcony and balustrade. They even re-created the custom 4-by-12-inch top rail on the new "old" porch.

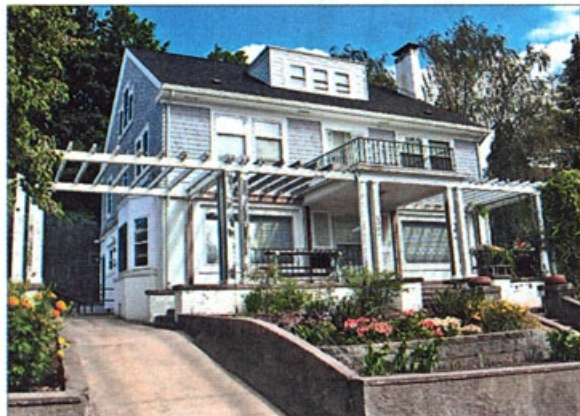
## | BEFORE |

The outside presented even bigger challenges. Stanton had cut off the original 3-foot eaves and removed the barge rafters and roof brackets. The original front porch was replaced by a flimsy wooden pergola, topped by an equally incongruous wrought-iron railing. What’s more, two 108-inch-wide “picture windows” had supplanted the original Craftsman window groupings at the front of the house.

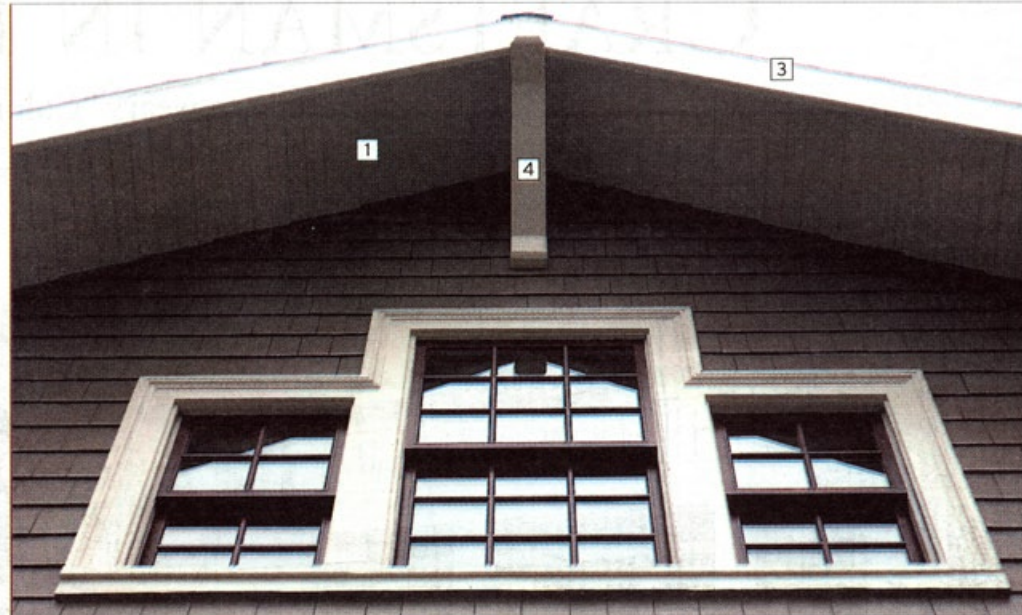
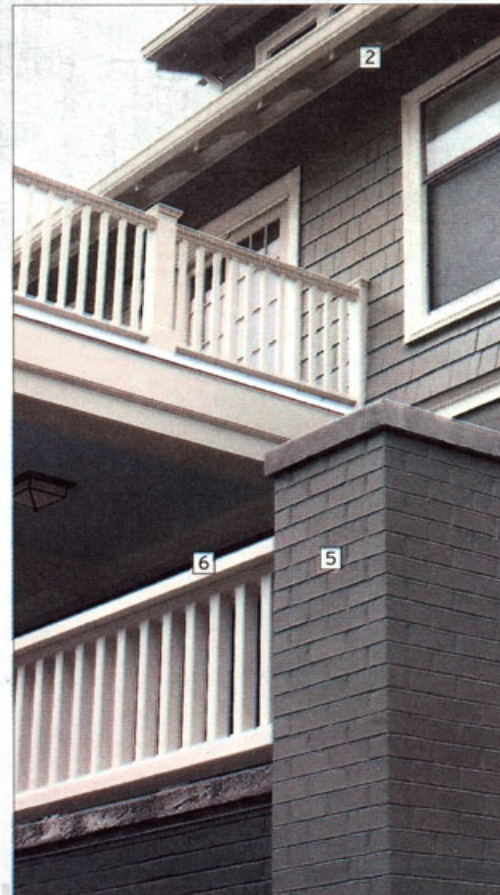
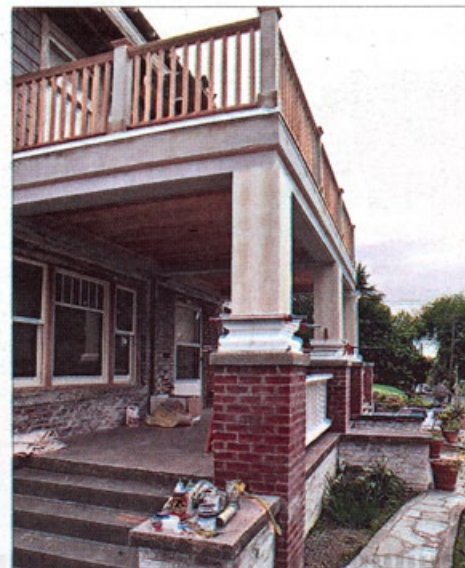
RESTORED ARCHITECTURAL DETAILS |

1. 3-foot eaves
2. Rafter tails
3. Barge rafters
4. Roof brackets
5. Brick piers
6. Balustrade

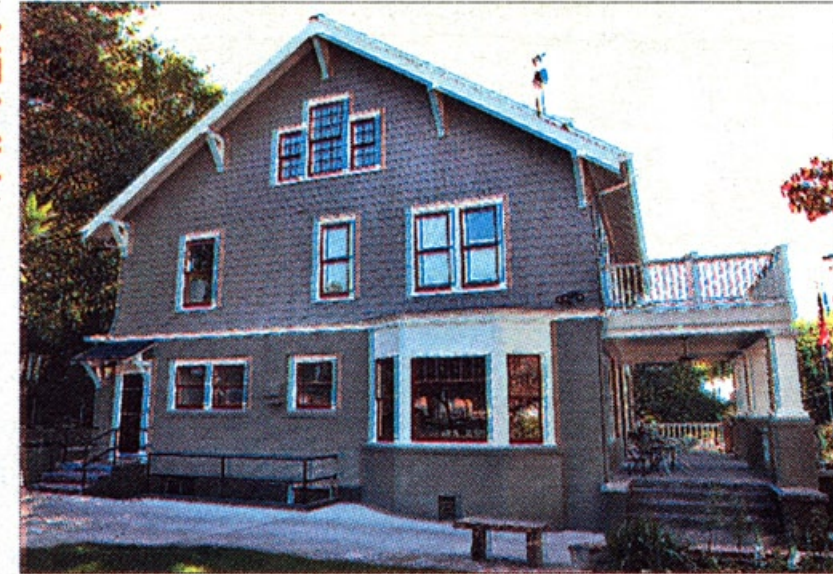
AFTER

An Arts and Crafts porch topped by a second-story balcony replaces an ill-fitting wooden pergola thought to have been added in a 1930s remodel.
